“FREEZE” LINING ON M12 FURNACE: MOTIVATION, INSTALLATION AND OPERATION

A.M. Hearn¹, A.S.J. van Rensburg² and J.R. Henning³

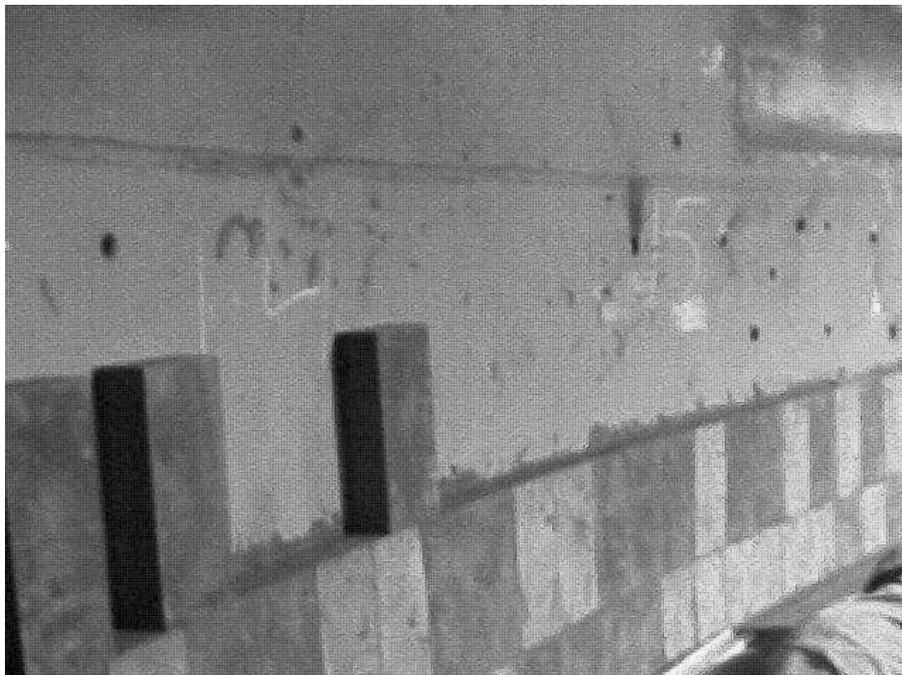
There are two distinct patterns in the lining that is installed in M12. The first is the sidewall lining that is based on the thermal equilibrium concept with the materials of very low thermal resistance. This is the standard “freeze” lining design. The photograph contained in figure 1 illustrates the graphite tiles being installed against the furnace shell.

Figure 1. M12 lining – graphite tiles installation.

The layers against the graphite tiles on the inside of the furnace, in the direction of the center, are the hot pressed carbon bricks with a layer of ceramic brick on the hot face of the lining. The function of the ceramic brick is to initiate the formation of the accreted layer and provide protection to the carbon bricks during the furnace start-up after the reline.

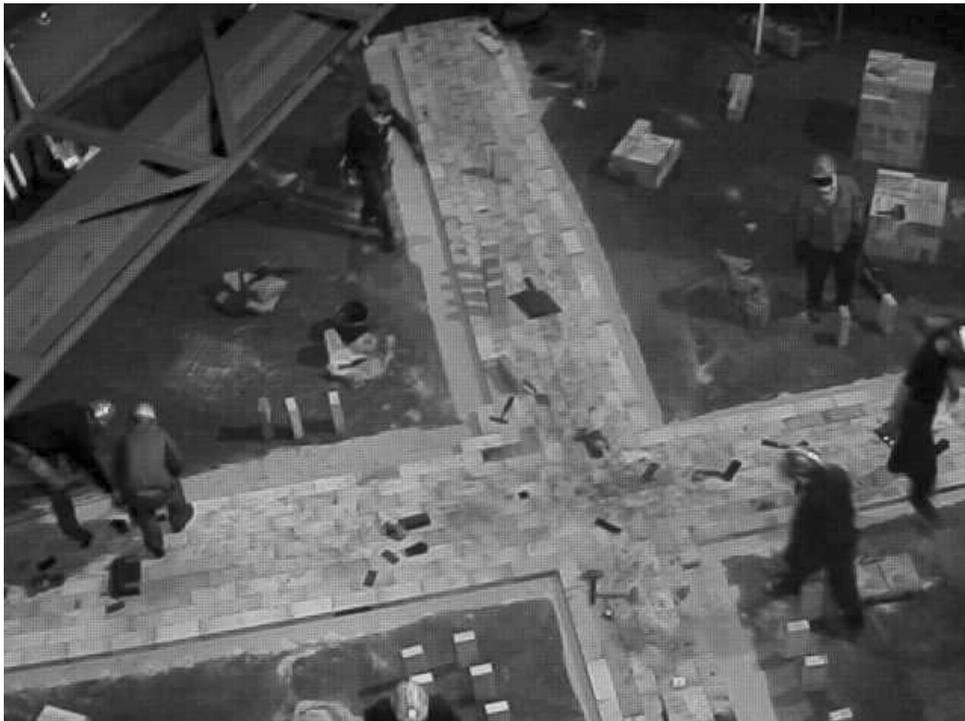
Figure 2. Laying of the ceramic brick in the floor of the furnace.

The photograph in figure 2 illustrates the laying of the ceramic brick on the floor of the furnace and figure 3 illustrates the laying of the carbon blocks. Note the theodolite in figure 3. The quality of the installation is extremely important to ensure that the integrity of the “freeze” lining is not compromised.

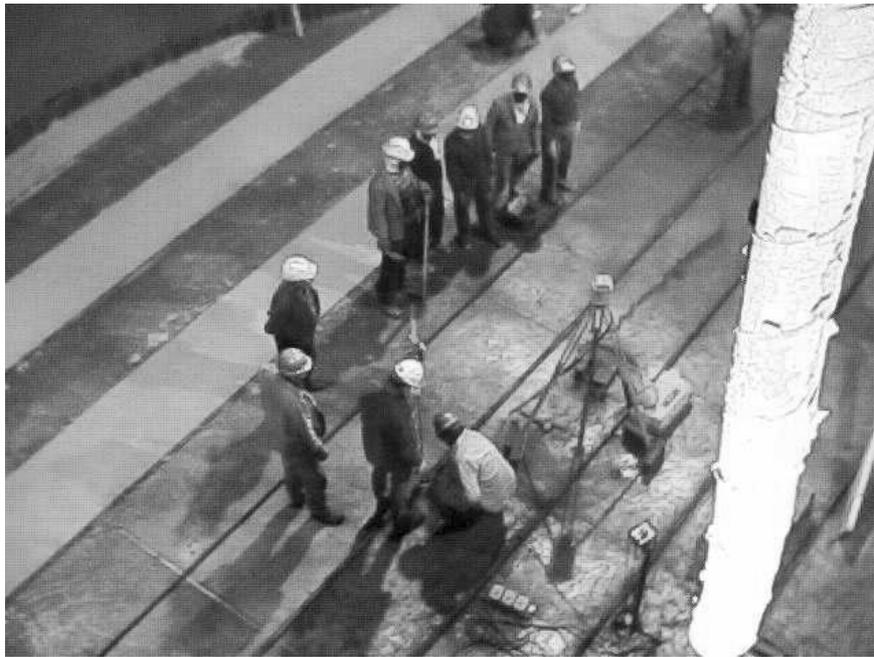
Figure 3. Laying of the carbon blocks in the floor of the furnace.

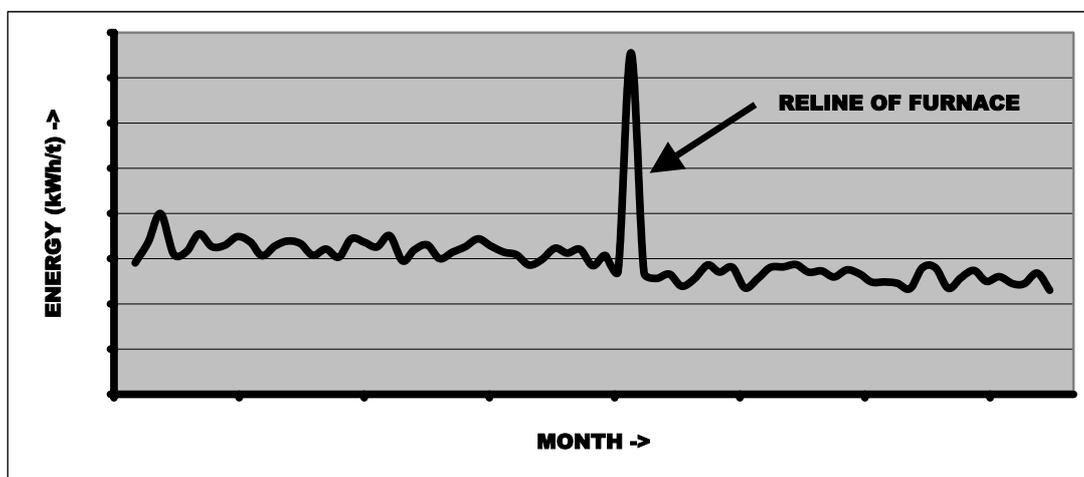
The principle financial gain with respect to lining of M12 has manifested itself in a reduction of specific energy consumption. The furnace reline started at the end of July 2000 and the furnace was out of operation for a period of 33 days. In the subsequent analysis the production during the start-up period has not been taken into account in the energy consumption averages. Figure 4 illustrates the monthly specific energy consumption in the production of high carbon ferromanganese on M12 furnace for the period May 1997 to present. The spike in the data indicates the operational perturbation as a result of the reline.

Figure 4. Specific energy consumption for the production of HCFeMn on M12.

Analysis of the data contained in figure 4 indicates an 18 percent improvement in the specific energy consumption, as measured in terms of kWh/t, between the period prior to August 2000 and the period subsequent to August 2000. In the period straddling September 2000 Metalloys undertook a number of initiatives that would have increased the efficiency of the operation by an estimated 10 percent. Assuming the additive nature of the efficiency improvements, with M12 partaking in these efficiency-improving initiatives, the efficiency improvement as a result of the “freeze” lining could conceivably not be more than about 8 percent. The following financial hypotheses are based on a saving of 8 percent and are based on South African 2003 costs.
