Challenges and solutions in PGM furnace operation: high matte temperature and copper cooler corrosion

by A. Shaw*, L.P.v.S. de Villiers†, R.J. Hundermark†, J. Ndlovu†, L.R. Nelson†, B. Pieterse†, R. Sullivan*, N. Voermann*, C. Walker*, F. Stober*, and A.D. McKenzie‡

Synopsis

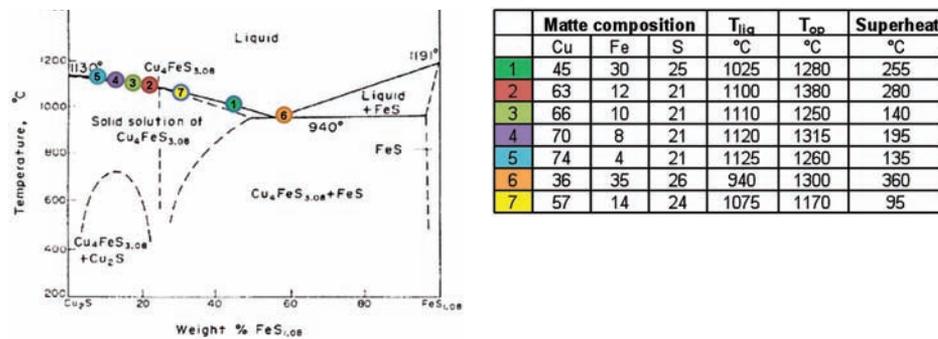
Figure 1—Copper primary matte liquidus temperatures (diagram after Schlegel and Schüller, 1952; matte composition information after Kapusta, 2004)

When one considers the copper matte formed in these furnaces, the matte liquidus temperatures range from around 940°C to around 1125°C, and a maximum difference of 360°C between the operating temperature and the matte liquidus temperature is observed (Figure 1).

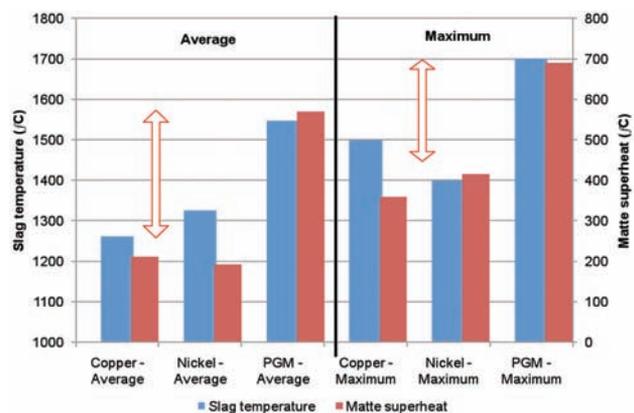
Figure 2—Comparison of operating temperatures and matte superheats across the copper, nickel, and PGM smelting industries

The average and maximum slag temperatures and matte superheats in the primary furnaces of the copper, nickel, and PGM smelting industries were calculated based on the information available in the aforementioned reviews and are shown in Figure 2. The step change increases in slag, and therefore operating, temperatures and most significantly matte superheats are evident for the PGM industry.

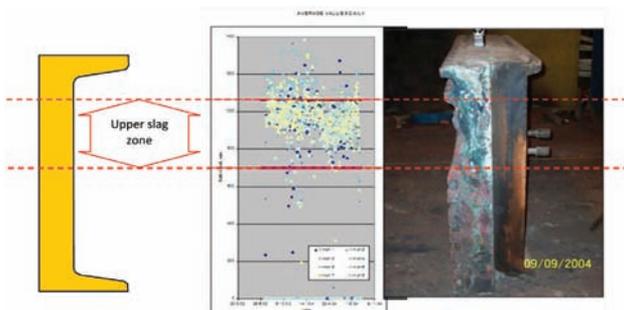
Figure 3—Location of maximum copper wear around slag-concentrate interface

In contrast to most other copper and nickel sulphide smelting operations, concentrate fed into PGM furnaces is not roasted. Corrosive species that are normally removed during concentrate roasting are instead released through heating and thermal decomposition of the concentrate in transit to and at the hot slag interface inside the furnace. These species tend to migrate and accumulate at the slag-concentrate interface near the walls, leading to pronounced wear of the coolers in this region (Figure 3).

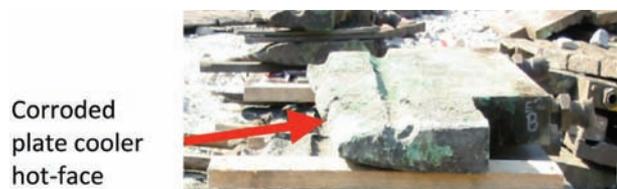
Figure 4—Severe upper plate cooler corrosion at Waterval Smelter. Note increased corrosion of upper plate cooler located in the furnace nearest the top of slag and concentrate interface

Corrosion is also not limited to waffle coolers. Given time, copper plate coolers in PGM furnaces are corroded to a short sharp edge (Figure 4), barely protruding into the furnace wall, and so reducing their cooling effect and upper wall stability. The corrosion is pervasive and continues to some extent throughout the furnace, not being limited to attack of copper, but also of basic magnesia-based refractories where magnesium sulphates (often resulting from sulphidation of

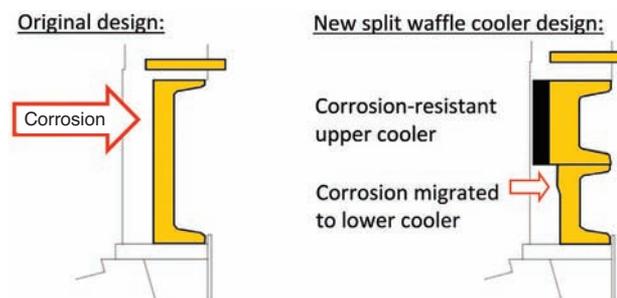
Figure 5—Initial copper loss in slag-concentrate interface zone. Following splitting of the coolers and protecting the upper block, copper corrosion migrated to the unprotected lower block

As part of the comprehensive plan to address corrosion, which is described later, the coolers were split horizontally into upper and lower blocks. After an effective corrosion-resistant barrier was applied to the hot face of the upper waffle coolers, the corrosion problem on these blocks significantly abated; however, the corrosion migrated to the 'deliberately' unprotected lower waffle coolers (Figure 5), though at a reduced rate.

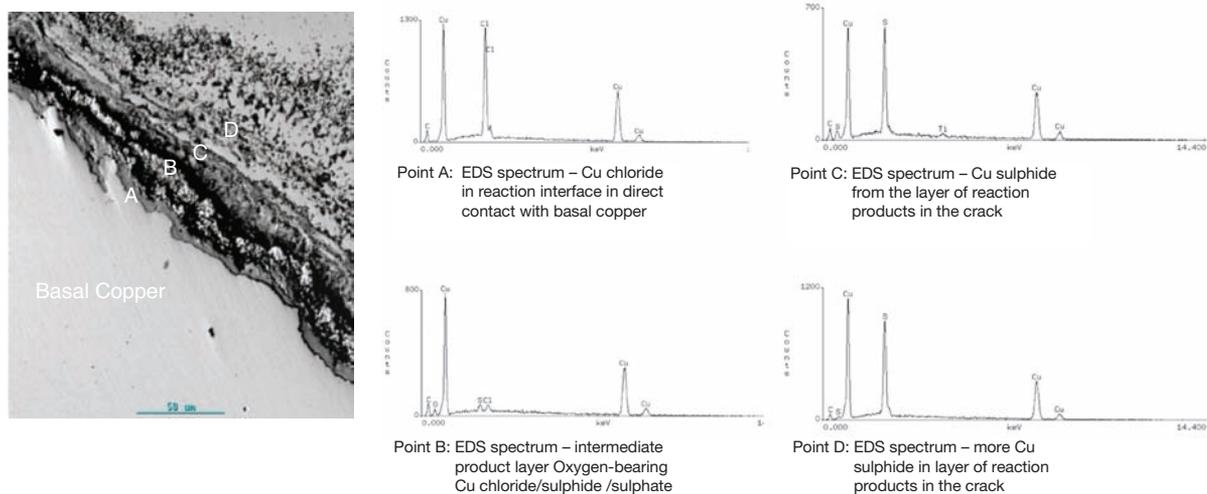
Figure 8—BSE image inside of a copper crack extending from a corrosion pit - typical sequence of corrosion product layers

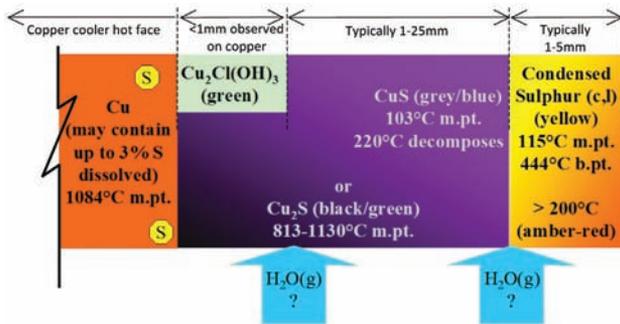
Figure 9—Schematic depiction of copper cooler and dominant species in its corrosion

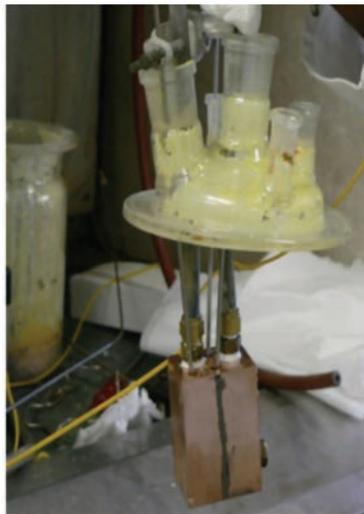
Figure 10—Suspended water-cooled copper test piece before insertion into test rig

To investigate this discrepancy, a special test rig was devised in an attempt to simulate copper cooler corrosion conditions. This comprised suspending water-cooled copper test blocks above a heated bath of sulphur, so exposing water-cooled copper to sulphur vapour (Figures 10–13). The results demonstrated that some direct sulphidation of water-cooled

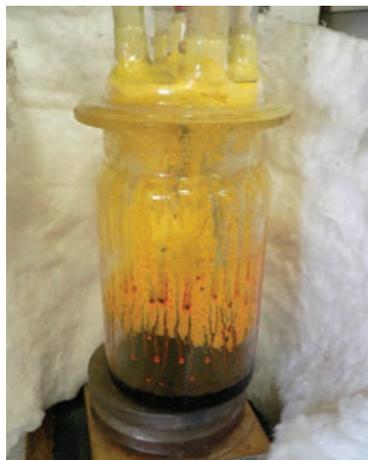
Figure 11—Sulphidation test rig with test sample inserted. Sulphur condensing and running down to liquid bath

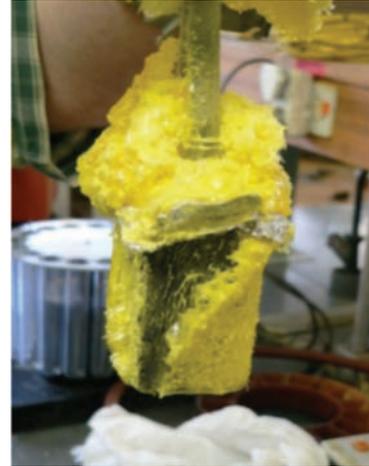
Figure 12—Water-cooled copper specimen coated with sulphur after testing

copper was indeed feasible even at a temperature as low as 25°C (0.2 mm over 14 days or 5.2 mm/a). As the copper temperature is raised to 90°C the corrosion rate increases to 16 mm/a. At a copper temperature of 125°C, the rate is

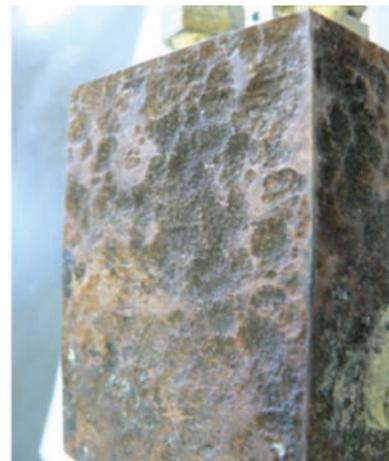
Figure 13—Copper corrosion at low 50°C temperature after only 5 days' exposure

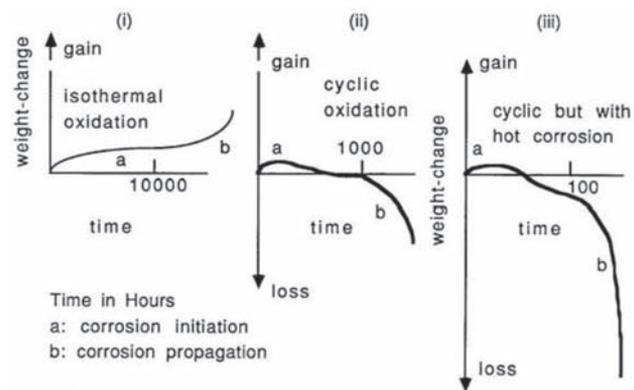
Figure 14—Corrosion mode typical of hot corrosion systems (after Hocking *et al.*, 1989)

The rate of 'hot corrosion' (by definition, corrosion in the presence of sulphur species) is inherently highly non-linear with respect to time (Figure 14). Coupled with the specific cooler conditions described above, this will further contribute

to a greatly accelerated rate of copper wear with cooler operating time. This is consistent with the great difficulty experienced in attempting to use condition-monitoring of copper thickness to predict the timing for safe replacement of the coolers before failure. In one instance of lower waffle cooler failure, involving detection through the automated water-pressure leak detection system of cooler water leaks into the Polokwane furnace, the mean rate of copper wear in front of the cast monel water pipes increased by over an order of magnitude in under a year, from 1.4 mm/a to 40.3 mm/a.

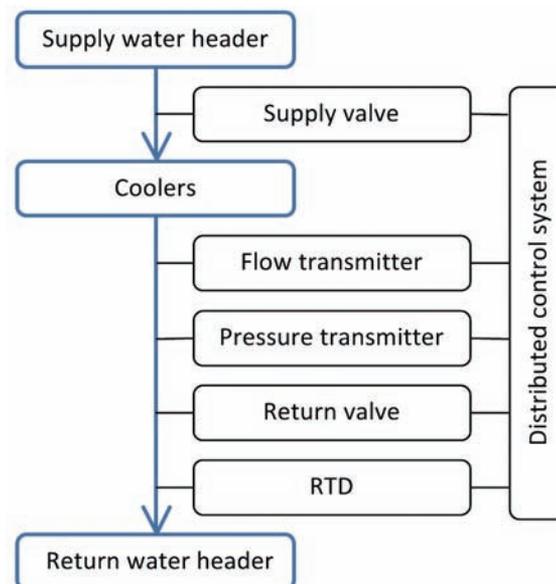
Figure 15—Schematic showing the automated pressure testing system components

An automatic water leak detection system was developed and installed on the cooler water circuits to detect pinhole leaks based on pressure (Figure 15). This system momentarily stops the flow of water on a circuit using valves at the inlet and outlet. A pressure transmitter then checks for a decrease in static pressure. The system is very sensitive, and leaks as small as a few drops per minute can be detected (Figure 16). Once detected, a leaking water circuit can be isolated because the cooler is designed with dual redundant water-cooling circuits. Consequently, a faulty cooler or piping can be replaced without further risk of refractory hydration or an explosion. This is not a continuous leak detection method, but it is automatically run at regular intervals selectable to as little as 4-hourly. This is the most direct and valuable monitoring system of the cooler condition available to operators.

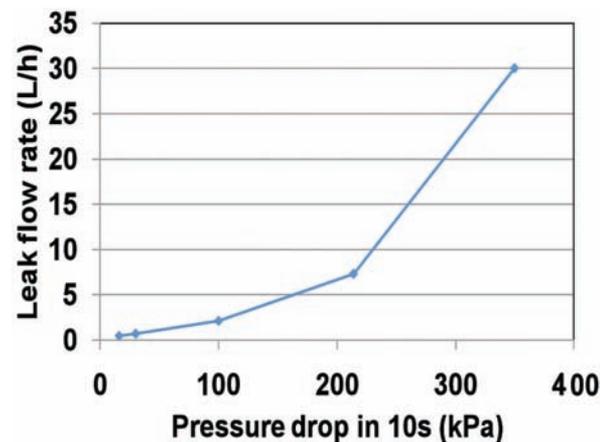
Figure 16—Leak simulation testing results indicating system sensitivity (Mahape, 2005)

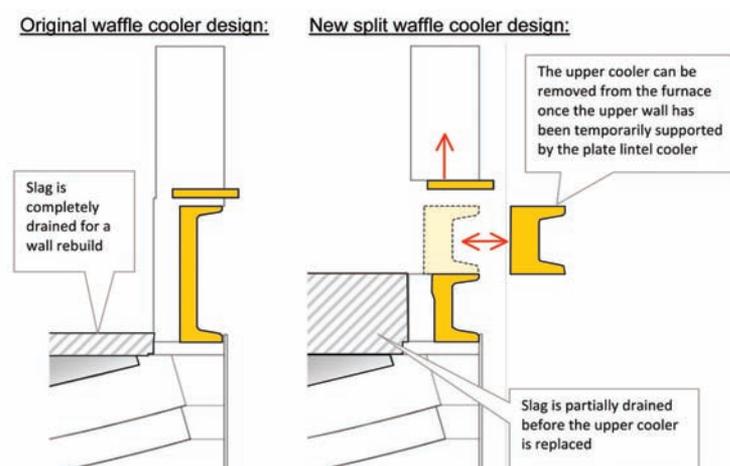
Figure 17—Diagram showing the original waffle coolers and the redesigned split coolers, which can be replaced quickly from outside a 'hot' furnace

It was possible to reduce the replacement cost of the waffle coolers by splitting them horizontally into upper and lower blocks because the most severe corrosion occurred mainly in the upper portion of the waffle coolers near the slag-concentrate interface (Figure 17). By doing this, the corrosion-prone upper waffle coolers could be replaced independently of the lower waffle coolers. One advantage of this arrangement is that the slag bath needs to be only

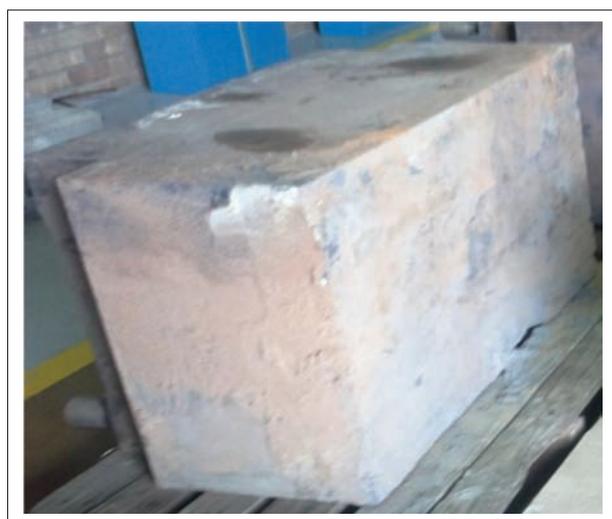
Figure 18—Upper cooler copper and graphite in pristine condition after being installed in the furnace for 12 months

Two consecutive planned annual inspections of the latest generation of graphite-protected copper coolers revealed the graphite to be in near pristine condition after 12 months' service. Given that the life of the original coolers was approximately one year, these results are very positive.

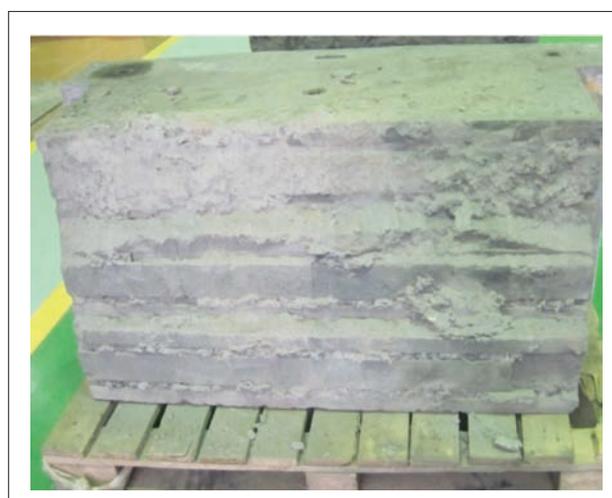
Figure 19—Perfect lower cooler graphite hot-face after being installed in the furnace for 12 months
