Challenges and solutions in PGM furnace operation: high matte temperature and copper cooler corrosion

by A. Shaw*, L.P.v.S. de Villiers†, R.J. Hundermark†, J. Ndlovu†, L.R. Nelson†, B. Pieterse†, R. Sullivan*, N. Voermann*, C. Walker*, F. Stober*, and A.D. McKenzie‡

Synopsis

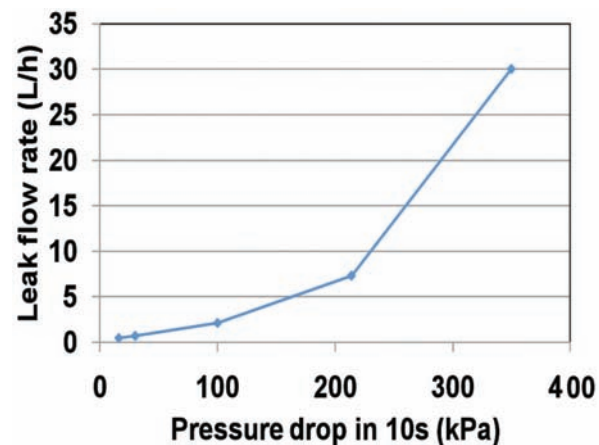
Figure 16—Leak simulation testing results indicating system sensitivity (Mahape, 2005)
