# Challenges and solutions in PGM furnace operation: high matte temperature and copper cooler corrosion

## Synopsis

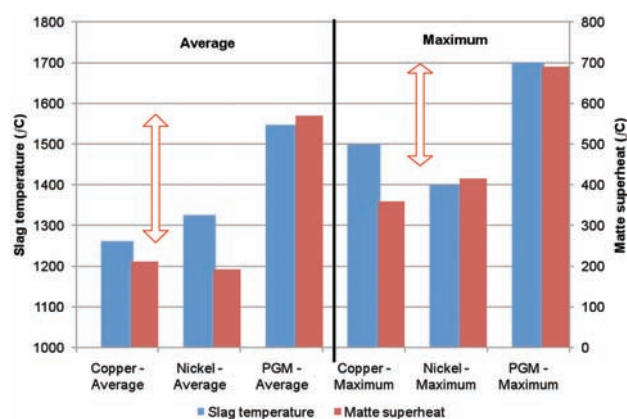
Figure 2—Comparison of operating temperatures and matte superheats across the copper, nickel, and PGM smelting industries

The average and maximum slag temperatures and matte superheats in the primary furnaces of the copper, nickel, and PGM smelting industries were calculated based on the information available in the aforementioned reviews and are shown in Figure 2. The step change increases in slag, and therefore operating, temperatures and most significantly matte superheats are evident for the PGM industry.

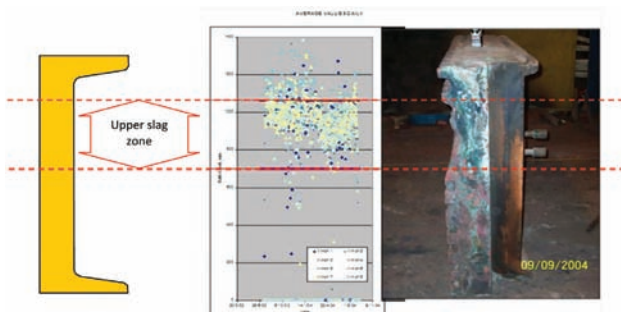
Figure 3—Location of maximum copper wear around slag-concentrate interface

In contrast to most other copper and nickel sulphide smelting operations, concentrate fed into PGM furnaces is not roasted. Corrosive species that are normally removed during concentrate roasting are instead released through heating and thermal decomposition of the concentrate in transit to and at the hot slag interface inside the furnace. These species tend to migrate and accumulate at the slag-concentrate interface near the walls, leading to pronounced wear of the coolers in this region (Figure 3).

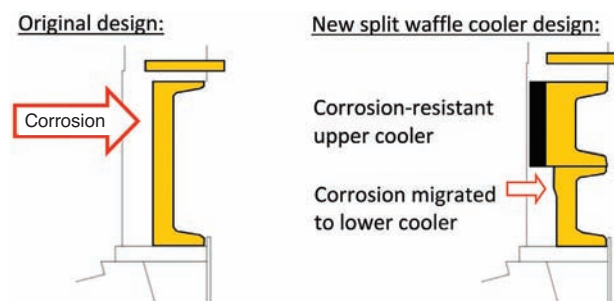
Figure 5—Initial copper loss in slag-concentrate interface zone. Following splitting of the coolers and protecting the upper block, copper corrosion migrated to the unprotected lower block

As part of the comprehensive plan to address corrosion, which is described later, the coolers were split horizontally into upper and lower blocks. After an effective corrosion-resistant barrier was applied to the hot face of the upper waffle coolers, the corrosion problem on these blocks significantly abated; however, the corrosion migrated to the 'deliberately' unprotected lower waffle coolers (Figure 5), though at a reduced rate.

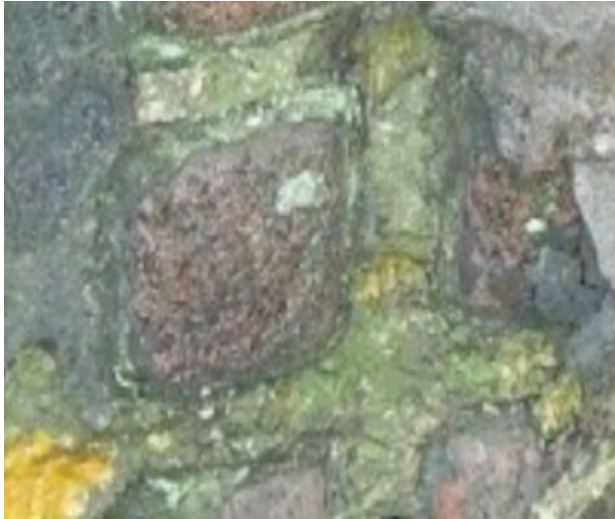
Figure 6—Typical corroded cooler – yellow elemental sulphur deposited on black copper sulfide corrosion product on copper. Grey covering is frozen slag accretion

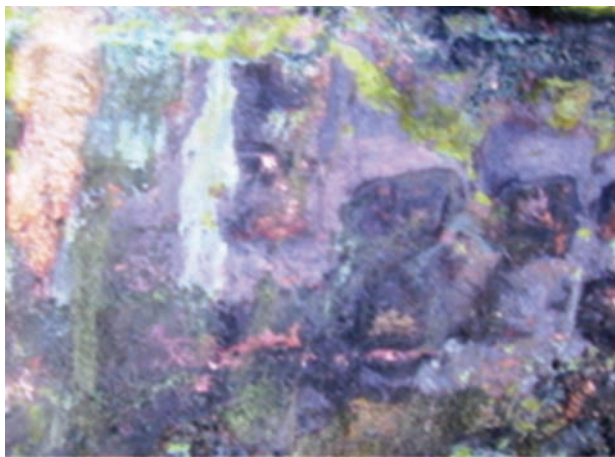
Figure 7—Severely corroded, unprotected copper block. Black copper sulphide pervasive. Increasing evidence of green copper hydroxy-chloride in close proximity to copper

In an attempt to simulate the presence of the thin copper chloride layer observed on most operational coolers (e.g., failed unprotected lower waffle cooler – Figure 7) a test was devised where the copper was first subjected to 1 day of exposure to 5 per cent HCl(g) by volume, followed by standard sulphidation with sulphur vapour. At a temperature of 90°C, after the initial exposure to HCl for 1 day, corrosion was not measurable.

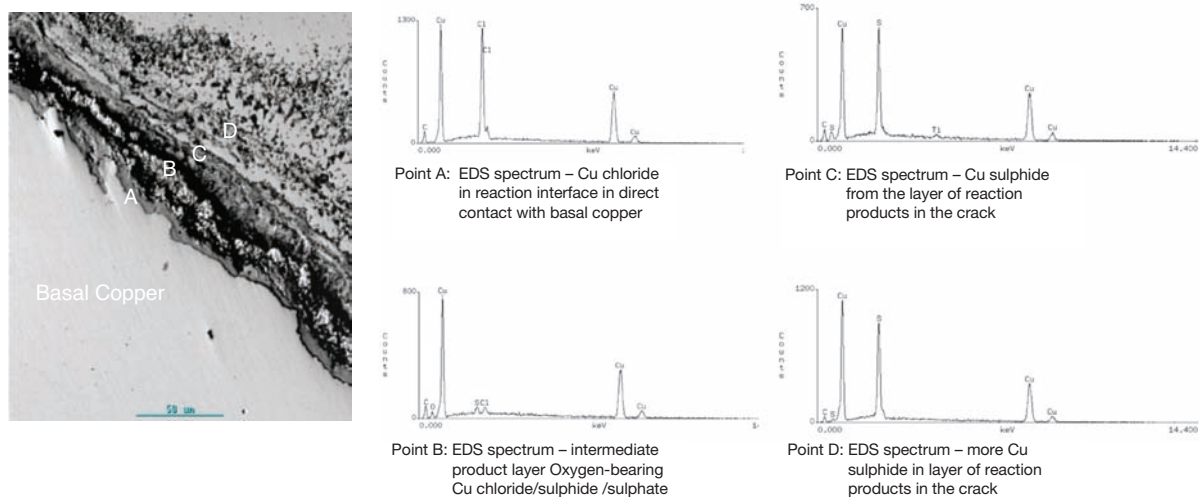
Figure 8—BSE image inside of a copper crack extending from a corrosion pit - typical sequence of corrosion product layers

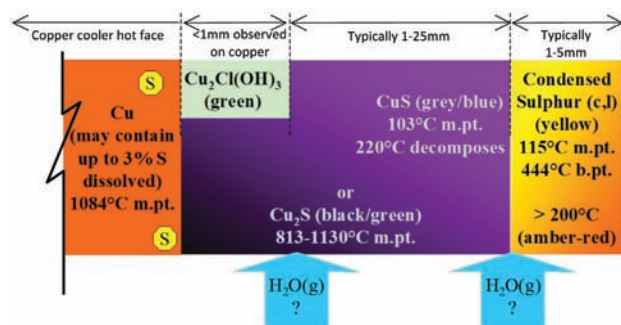
Figure 9—Schematic depiction of copper cooler and dominant species in its corrosion

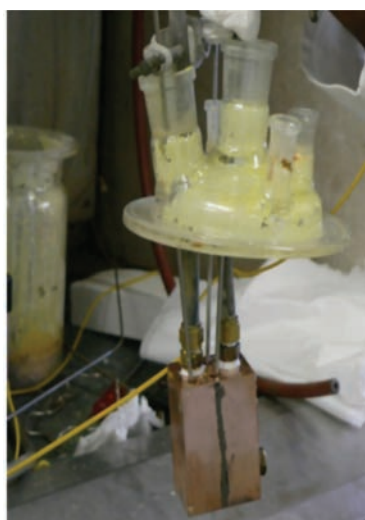
Figure 10—Suspended water-cooled copper test piece before insertion into test rig

To investigate this discrepancy, a special test rig was devised in an attempt to simulate copper cooler corrosion conditions. This comprised suspending water-cooled copper test blocks above a heated bath of sulphur, so exposing cooled copper to sulphur vapour (Figures 10–13). The results demonstrated that some direct sulphidation of water-cooled

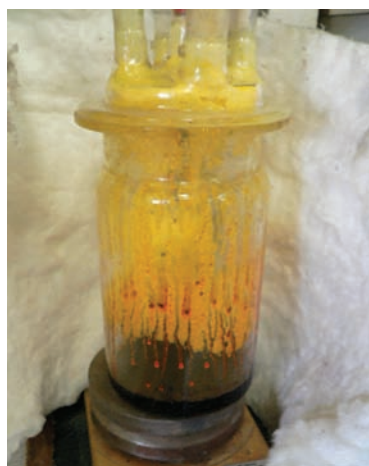
Figure 11—Sulphidation test rig with test sample inserted. Sulphur condensing and running down to liquid bath

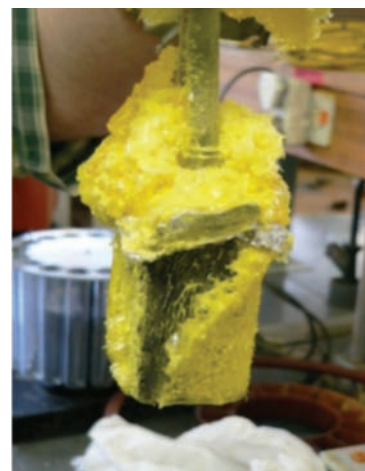
Figure 12—Water-cooled copper specimen coated with sulphur after testing

copper was indeed feasible even at a temperature as low as 25°C (0.2 mm over 14 days or 5.2 mm/a). As the copper temperature is raised to 90°C the corrosion rate increases to 16 mm/a. At a copper temperature of 125°C, the rate is

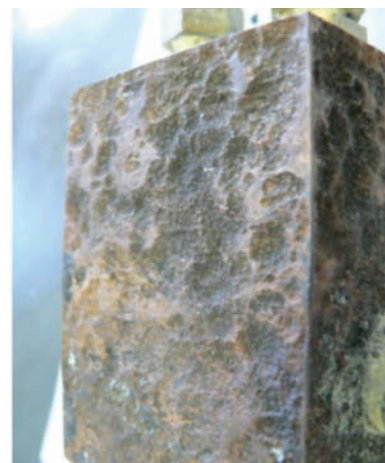
Figure 13—Copper corrosion at low 50°C temperature after only 5 days' exposure

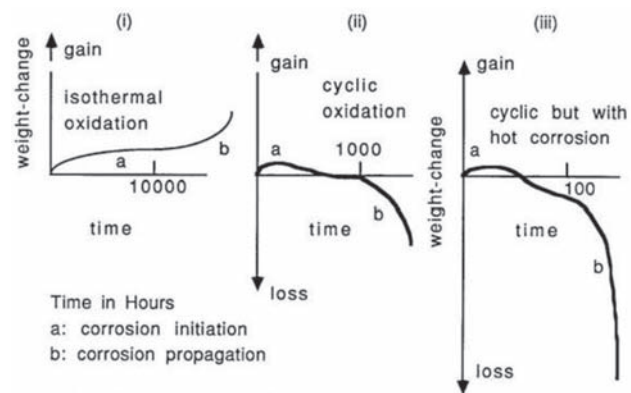
Figure 14—Corrosion mode typical of hot corrosion systems (after Hocking *et al.*, 1989)

The rate of 'hot corrosion' (by definition, corrosion in the presence of sulphur species) is inherently highly non-linear with respect to time (Figure 14). Coupled with the specific cooler conditions described above, this will further contribute

to a greatly accelerated rate of copper wear with cooler operating time. This is consistent with the great difficulty experienced in attempting to use condition-monitoring of copper thickness to predict the timing for safe replacement of the coolers before failure. In one instance of lower waffle cooler failure, involving detection through the automated water-pressure leak detection system of cooler water leaks into the Polokwane furnace, the mean rate of copper wear in front of the cast monel water pipes increased by over an order of magnitude in under a year, from 1.4 mm/a to 40.3 mm/a.

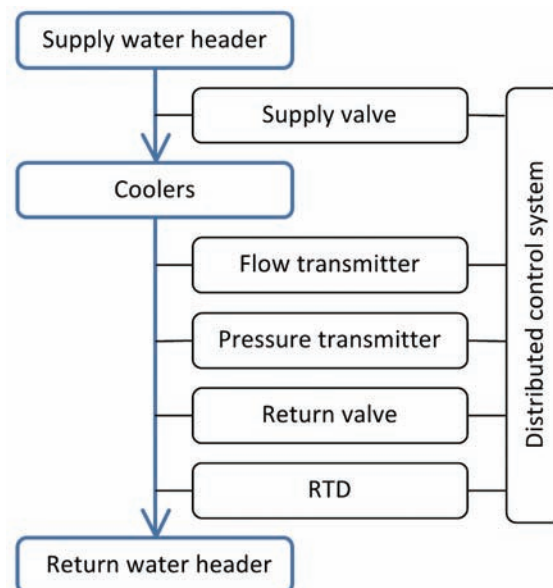
Figure 15—Schematic showing the automated pressure testing system components

An automatic water leak detection system was developed and installed on the cooler water circuits to detect pinhole leaks based on pressure (Figure 15). This system momentarily stops the flow of water on a circuit using valves at the inlet and outlet. A pressure transmitter then checks for a decrease in static pressure. The system is very sensitive, and leaks as small as a few drops per minute can be detected (Figure 16). Once detected, a leaking water circuit can be isolated because the cooler is designed with dual redundant water-cooling circuits. Consequently, a faulty cooler or piping can be replaced without further risk of refractory hydration or an explosion. This is not a continuous leak detection method, but it is automatically run at regular intervals selectable to as little as 4-hourly. This is the most direct and valuable monitoring system of the cooler condition available to operators.

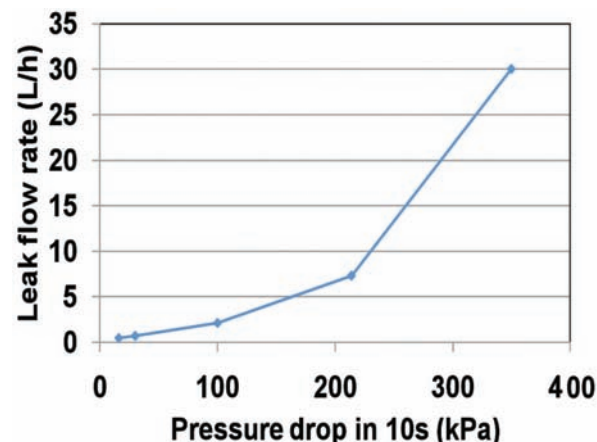
Figure 16—Leak simulation testing results indicating system sensitivity (Mahape, 2005)

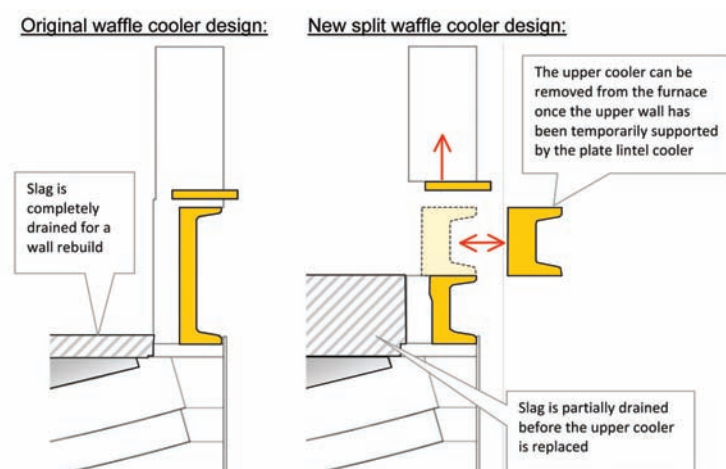
Figure 17—Diagram showing the original waffle coolers and the redesigned split coolers, which can be replaced quickly from outside a 'hot' furnace

It was possible to reduce the replacement cost of the waffle coolers by splitting them horizontally into upper and lower blocks because the most severe corrosion occurred mainly in the upper portion of the waffle coolers near the slag-concentrate interface (Figure 17). By doing this, the corrosion-prone upper waffle coolers could be replaced independently of the lower waffle coolers. One advantage of this arrangement is that the slag bath needs to be only

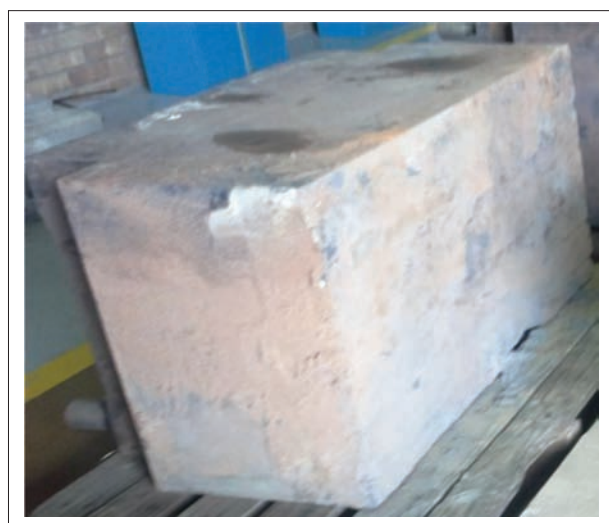
Figure 18—Upper cooler copper and graphite in pristine condition after being installed in the furnace for 12 months

Instead, a number of methods of protecting the coolers from corrosion were developed and tested. Of these, the installation of a graphite barrier on the hot face of the copper coolers has proven to be the preferred option. For the graphite to survive in the furnace, good thermal contact is required between it and the copper cooler behind it. If this contact is not maintained, the graphite will overheat in contact with the slag bath, leading to rapid graphite oxidization, CO bubble-induced stirring, and very high convective heat fluxes. To avoid this loss of thermal contact, stresses induced in the graphite due to differential thermal expansion and movement of the surrounding furnace refractory were minimized in the design of the graphite-protected cooler system.

Two consecutive planned annual inspections of the latest generation of graphite-protected copper coolers revealed the graphite to be in near pristine condition after 12 months' service. Given that the life of the original coolers was approximately one year, these results are very positive.

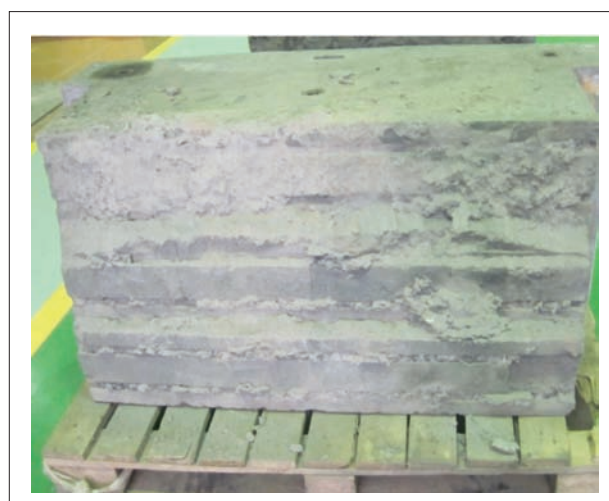
Figure 19—Perfect lower cooler graphite hot-face after being installed in the furnace for 12 months
