# Challenges and solutions in PGM furnace operation: high matte temperature and copper cooler corrosion

by A. Shaw\*, L.P.v.S. de Villiers†, R.J. Hundermark†, J. Ndlovu†, L.R. Nelson†, B. Pieterse†, R. Sullivan\*, N. Voermann\*, C. Walker\*, F. Stober\*, and A.D. McKenzie‡

## Synopsis

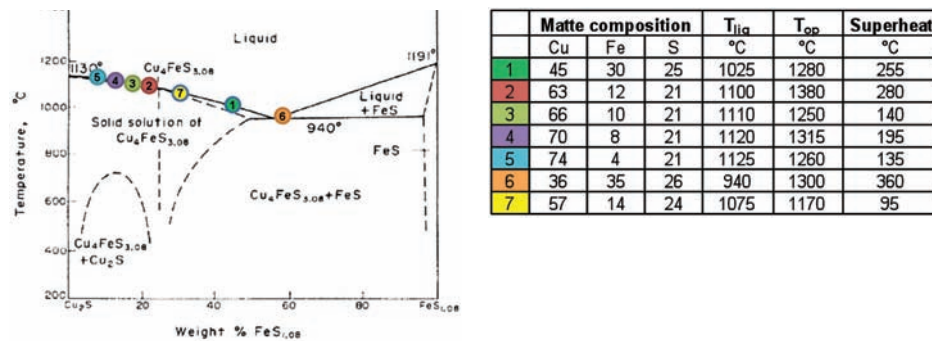
Figure 1—Copper primary matte liquidus temperatures (diagram after Schlegel and Schüller, 1952; matte composition information after Kapusta, 2004)

When one considers the copper matte formed in these furnaces, the matte liquidus temperatures range from around 940°C to around 1125°C, and a maximum difference of 360°C between the operating temperature and the matte liquidus temperature is observed (Figure 1).

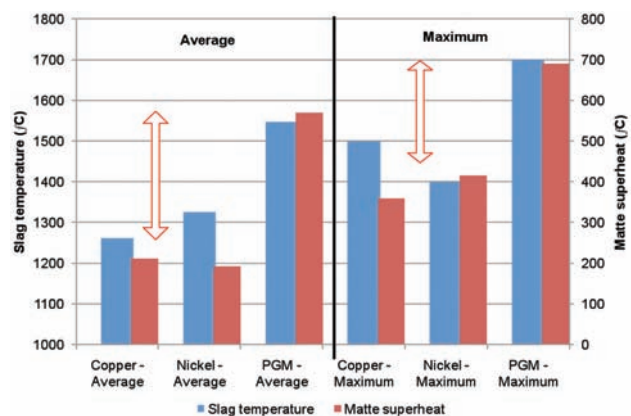
Figure 2—Comparison of operating temperatures and matte superheats across the copper, nickel, and PGM smelting industries

The average and maximum slag temperatures and matte superheats in the primary furnaces of the copper, nickel, and PGM smelting industries were calculated based on the information available in the aforementioned reviews and are shown in Figure 2. The step change increases in slag, and therefore operating, temperatures and most significantly matte superheats are evident for the PGM industry.

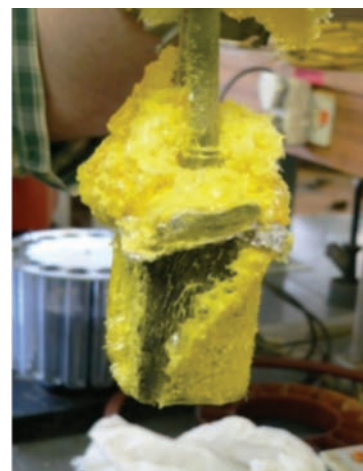
Figure 12—Water-cooled copper specimen coated with sulphur after testing

copper was indeed feasible even at a temperature as low as 25°C (0.2 mm over 14 days or 5.2 mm/a). As the copper temperature is raised to 90°C the corrosion rate increases to 16 mm/a. At a copper temperature of 125°C, the rate is

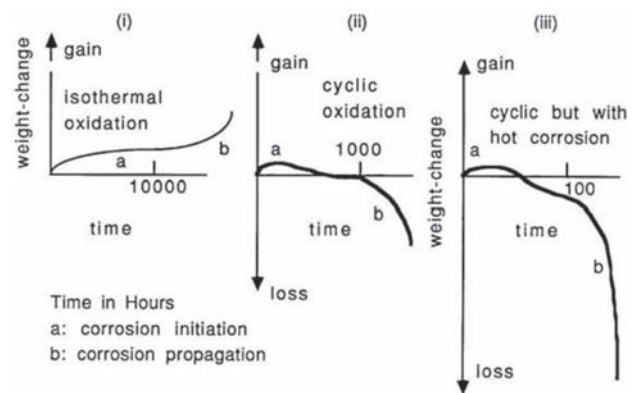
Figure 14—Corrosion mode typical of hot corrosion systems (after Hocking *et al.*, 1989)

The rate of 'hot corrosion' (by definition, corrosion in the presence of sulphur species) is inherently highly non-linear with respect to time (Figure 14). Coupled with the specific cooler conditions described above, this will further contribute

to a greatly accelerated rate of copper wear with cooler operating time. This is consistent with the great difficulty experienced in attempting to use condition-monitoring of copper thickness to predict the timing for safe replacement of the coolers before failure. In one instance of lower waffle cooler failure, involving detection through the automated water-pressure leak detection system of cooler water leaks into the Polokwane furnace, the mean rate of copper wear in front of the cast monel water pipes increased by over an order of magnitude in under a year, from 1.4 mm/a to 40.3 mm/a.
