An Anatomy of Furnace Refractory Erosion: Evidence from a Pilot-Scale Facility

Paul den Hoed
MINTEK
Private Bag X3015
2125 Randburg
South Africa
Telephone +27-11-709-4735
Telefax +27-11-709-4564
denhoed@mintek.co.za

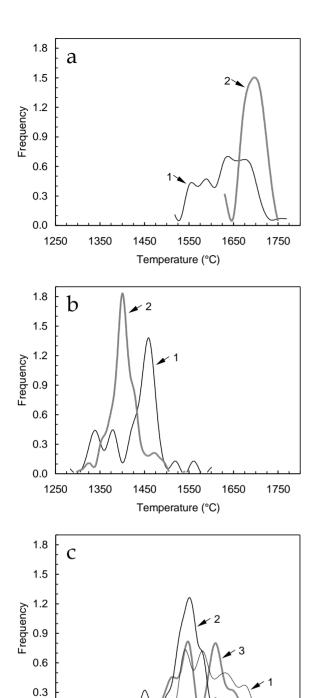
Figure 1. Temperatures of Tapped Slags (normalized variations in temperature).

a. Smelting of nickel laterite.

b. Smelting of lead blast-furnace slag.

c. Smelting of Cu reverberatory-furnace slag.

The numbers refer to campaigns (see Table I).

periods (Table IV). Temperatures were also different (Figure 1). On the assumption that the temperature of tapped slag reflects the temperature within the furnace, we can see that the second campaign in the smelting of lead blast-furnace slag maintained relatively low temperatures (~1400°C); the second campaign in the smelting of nickel laterite, the hottest temperatures (~1700°C). The difference relates to the higher liquidus of the MgO-FeO-SiO₂ slag from nickel laterites compared with that of the CaO-FeO-SiO₂ slag from LBFS. ^{11, 12}

That said, however, a brick of fused-spinel from the freeboard of the second LBFS campaign showed spalling (Figure 11). Although slag temperatures in the bath were much cooler (*cf.* figures 1b and 1c), the

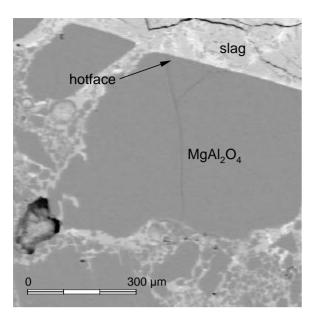
Figure 3. Refractory-Slag Interactions at the Hotface of a Spinel Brick. Micrograph of the backscattered-electron image.

- As Figure 3 strikingly shows, the slag-refractory interface 'slices through' MgAl₂O₄ (spinel) grains at the eroded face of the fused-spinel brick; the interface is sharp and smooth over the full surface of the hot-face. No loose grains of spinel lay in the layer of slag adhering to the hot-face, a sign that the refractory had not first been weakened by corrosion and then washed by currents into the bath.
- Slag penetrates the matrix in both brick and castable. Within the pores, its composition is enriched in Al₂O₃. Analyses of the slag phase trace a sharp increase in the level of Al₂O₃ from a point at the hot-face (~10%) to one just behind it (>25%). There was no evidence that the reaction of slag with MgAl₂O₄ (spinel) in the pores of the refractory contributed to erosion.

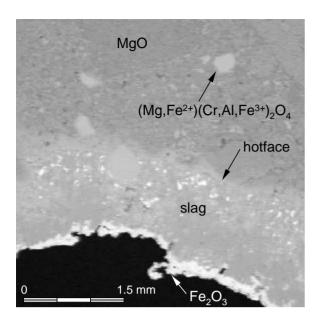
Figure 4. Refractory-Slag Interactions at the Hotface of a Magnesia-Chrome Brick. Micrograph of the backscattered-electron image.

- The hot-face defines a sharp boundary between the refractory and the slag of the bath (Figure 4). We would interpret this feature as erosion by dissolution.
- Not only is the cooled slag adjacent to the hot-face enriched in Mg²⁺, but, where it has been left relatively undisturbed, a spinel rich in magnesia and chrome has crystallized from the molten slag. This phase and its chrome-magnesia-rich composition indicate that the slag in this area, shielded from turbulence in the slag bath, had reached saturation, the outcome of a dissolution process.

Not surprisingly, without a freeze-lining to protect them, the magnesia-chrome bricks that contained the slag bath were severely eroded in the shorter campaign and entirely consumed within 18 days (Table IV). Erosion was just as severe in magnesia-chrome refractories lining the lower sections of the freeboard.

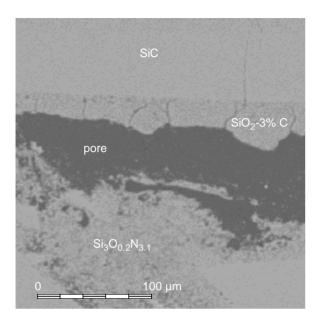
Figure 8. Near the Hot-Face of SiC-Si $_3$ N $_4$ Refractory: Formation of SiO $_2$.

- Specs of carbon in the matrix of the refractory.
- A layer of silica (SiO₂) on the surfaces of many particles of SiC (Figure 8). This would suggest that conditions in the furnace were sufficiently oxidizing for SiO₂ to form from SiC.

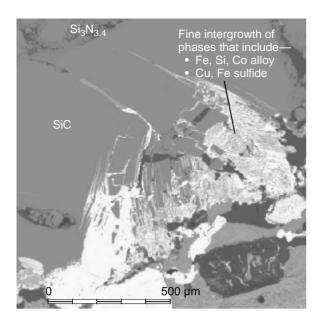
Figure 9. Near the Hot-Face of SiC-Si₃N₄ Refractory: Si-Enriched Metal.

• An alloy phase containing high levels of silicon (Figure 9—an analysis of the alloy at one point recorded 15% Si).

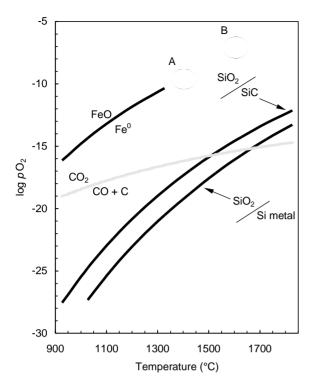
Figure 10. Oxygen Potential Diagram: Relative Stabilities of Different Buffers.

(Constructed from thermochemical data.¹⁵) The two shaded discs mark desirable operating conditions—

- **A** For the smelting of LBFS.
- **B** For the smelting of CRFS.

At these conditions, the reduction of Fe²⁺ to metallic iron should be minimal.

To explain these features, we refer to the oxygen potentials of several buffers (Figure 10). Each of the shaded discs represents a set of desirable operating conditions for a campaign. Here, desirable refers to the minimal reduction of iron from the slag so that the liquid alloy will concentrate the valuable metals. The equilibrium curves for these metals lie above the shaded discs, which in turn lie close to the Fe⁰-FeO buffer. These operating conditions will oxidize SiC to SiO₂: the reaction is driven by an oxygen potential of ~8 log pO_2 units, the difference in oxygen fugacities of the shaded discs and the SiC-SiO₂ buffer. Within the lining, the presence of SiO₂ and SiC will establish a local oxygen fugacity according to the SiC-SiO₂ buffer curve. In practice, by virtue of its proximity to the Si-SiO₂ buffer—less than 2 log pO_2 units separate the two buffer curves—this pO_2 is sufficiently reducing for the formation of a dilute, Si-bearing alloy. Thus, conditions near the hot-face of a SiC refractory stabilize SiO₂ and silicon. SiO₂, being soluble in slag, will facilitate the erosion of the lining. Silicon, on the other hand, should report to the liquid alloy. This, indeed, is what happened.
